# Optimizing Sheet Margin Protection from Contaminants

## I. INTRODUCTION

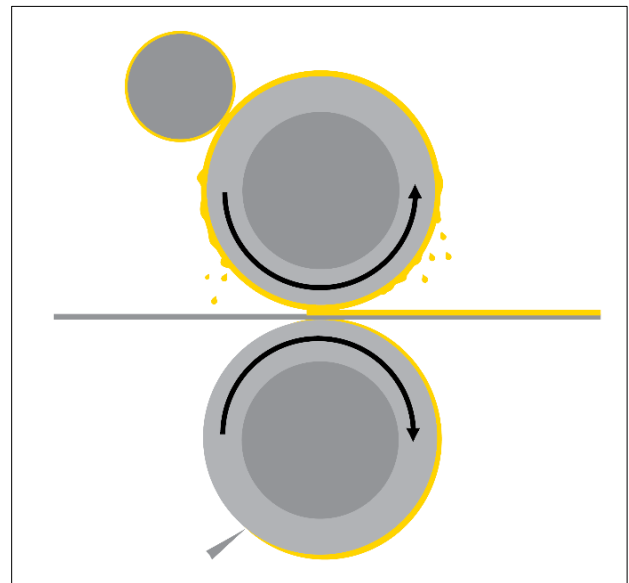
Figure 5: Lacquer with low viscosity on the roller

However, the viscosity is very much temperature-dependent. If the viscosity is adjusted while the temperature is too low and the temperature subsequently rises when the press has been running for a while, the viscosity could become too low.

A certain degree of thickness is required for the lacquer to stick to the lacquering roll during coating. In addition, if the lacquer is too thin, it will not stick to the lacquering roll very well. This will cause little drops to fly off and easily detach from the roller like water.
